EXPLORATORY DEVELOPMENT OF RAIN EROSION RESISTANT INFRARED
WINDOW MATERIALS

Bell Aerospace Textron
Post Office Box One
Buffalo, New York 14240

TECHNICAL REPORT AFML-TR-77-84

Final Report for Period February 1976 - February 1977

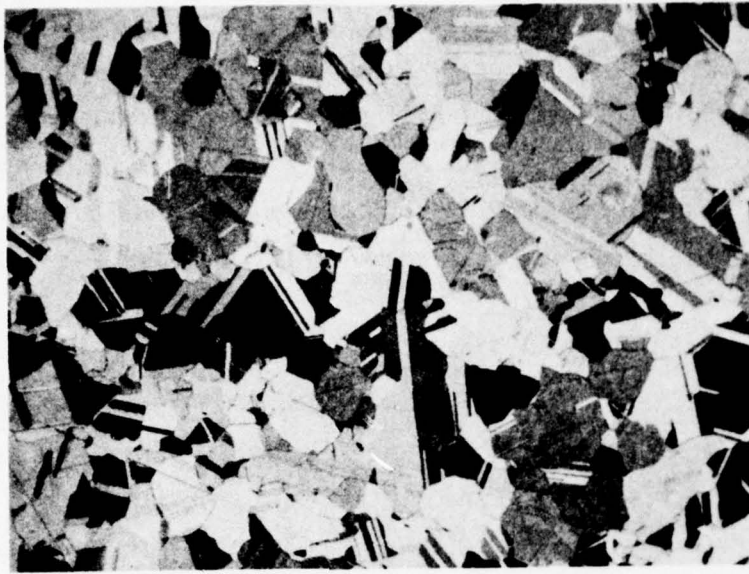
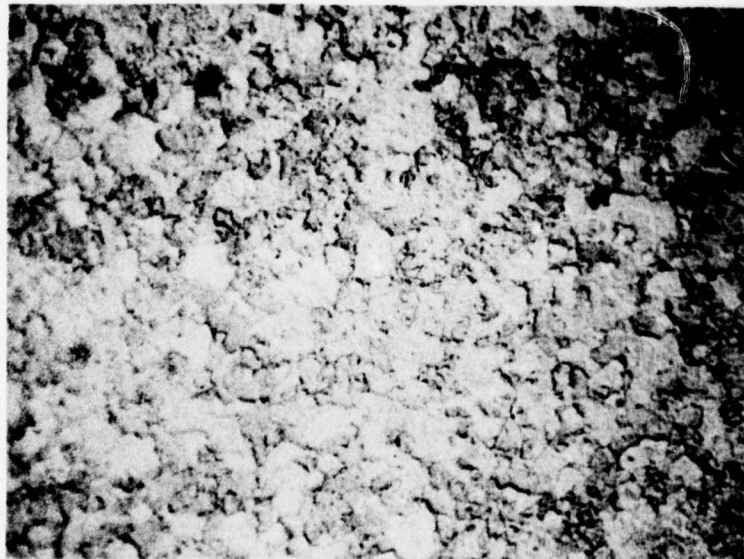
a. Grain Structure of Zinc Selenide, Mag. 135X

b. Grain Structure of Zinc Sulfide, Mag. 600X

Figure 1. Microstructure of Infrared Window Materials (Continued)

Figure 1. Microstructure of Infrared Window Materials (Concluded)

Figure 1 shows the grain structure of the zinc selenide and the zinc sulfide. The zinc selenide has a relatively large grain size with many grains containing twins: the zinc sulfide has an extremely fine grain size. The etched gallium arsenide specimen was found to be composed of five grains, two of which were quite large. The grain boundaries were essentially perpendicular to the 1.50 in. dimension on the specimen, although one grain did not extend completely across the specimen. Knoop microhardnesses (50 gm load) of the zinc selenide, zinc sulfide, and gallium arsenide were measured to be 100, 290, and 635, respectively.

Transmission electron microscopic examination of replicas from etched specimens showed that the grain boundaries of all three materials were narrow and free of any precipitates. The only significant feature found on any of the three materials was the presence of extremely small precipitates within the grains of the gallium arsenide as shown in Figure 1c.

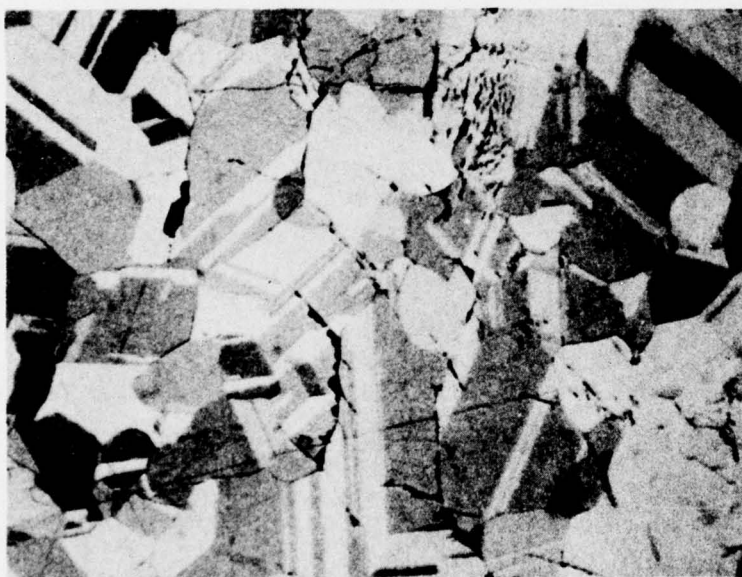
a. Overall Appearance, Transmitted Light. Mag. 135X

b. Overall Appearance. Mag. 135X

Figure 5. Ring Fracture on Zinc Selenide Formed by Impact with 0.7 mm Diameter Drop at 730 fps. Reflected Light Except Where Noted (Continued)

c. Transgranular Cracks in Area A. Mag. 250X

d. Evidence of Intergranular Cracks in Area B. Mag. 250X

e. Etch Pits at Inner Radius of Ring Fracture in Area C. Mag. 470X

Figure 5. Ring Fracture on Zinc Selenide Formed by Impact with 0.7 mm Diameter Drop at 730 fps. Reflected Light Except Where Noted (Concluded)

Optical micrographs, after etching, of a ring fracture formed on zinc selenide by impact with a 0.7 mm diameter water drop at 730 fps are presented in Figure 5. Transmitted light was used in Figure 5a to show the overall appearance of the fracture in relation to the grain structure. Transmitted light was found to be particularly useful in revealing surface fractures, as well as the location and extent of subsurface damage, on the optically transparent zinc selenide and zinc sulfide specimens. Subsurface damage as revealed by transmitted light would include both cracks which did not extend to the surface and surface cracks which changed direction to become more nearly parallel to the surface. Most of the loss in optical transmission in Figure 5a appears to be caused by the latter, i.e., surface cracks which change angle below the surface.

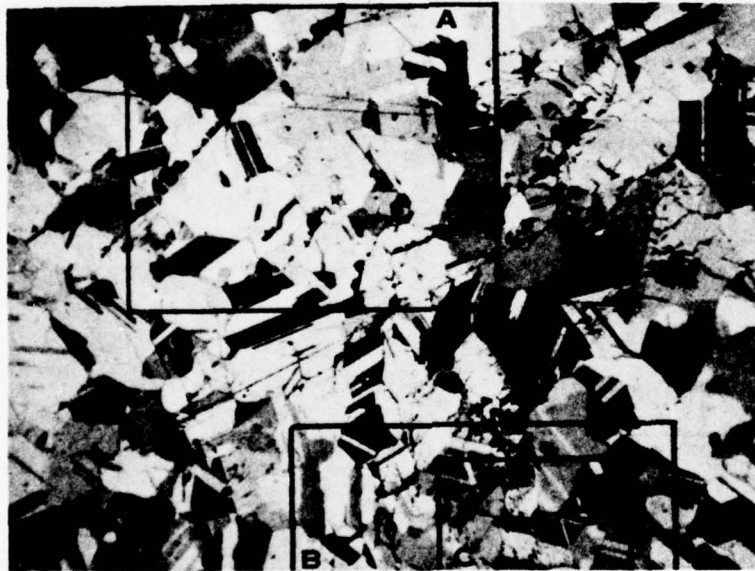
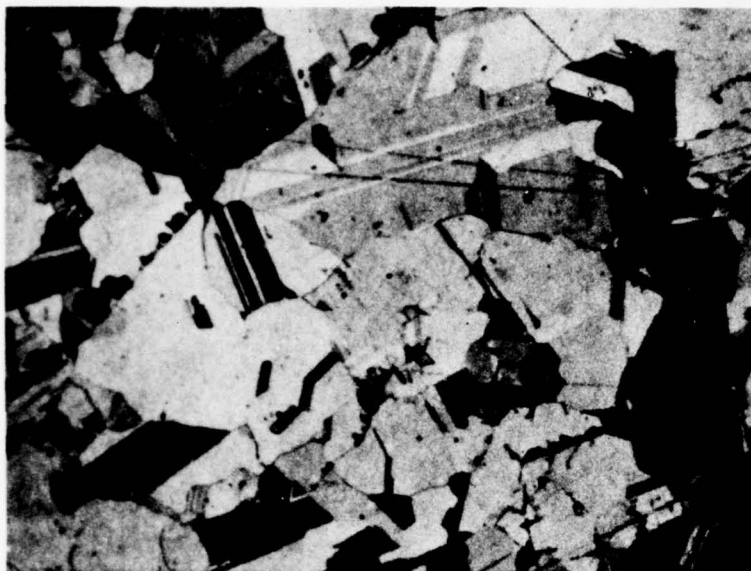
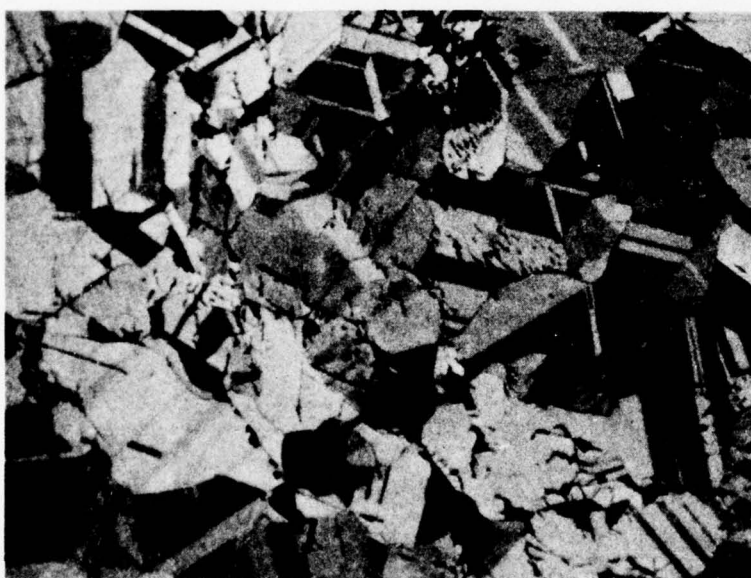
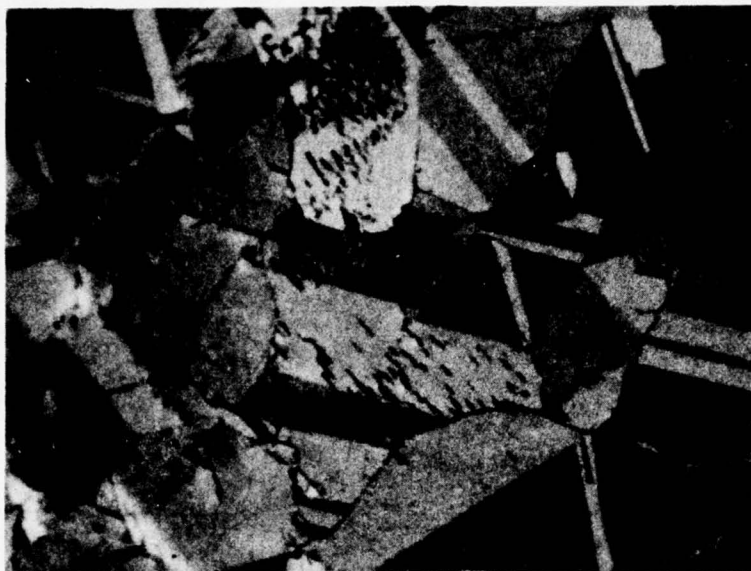
a. Overall Appearance, Transmitted Light. Mag. 30X

b. Appearance of Left Side. Mag. 135X

Figure 6. Ring Fracture on Zinc Selenide Formed by Impact with 2.0 mm Diameter Drop at 730 fps. Reflected Light Except Where Noted (Continued)

c. Transgranular Cracks in Area A. Mag. 250X

d. Evidence of Intergranular Cracks in Area B. Mag. 250X

e. Etch Pits at Inner Radius of Ring Fracture in Area C. Mag. 470X

**Figure 6. Ring Fracture on Zinc Selenide Formed by Impact with 2.0 mm Diameter Drop
at 730 fps. Reflected Light Except Where Noted
(Concluded)**

Optical micrographs, after etching, of a ring fracture formed on zinc selenide by impact with a 2.0 mm diameter water drop at 730 fps are presented in Figure 6. Figure 6a shows the overall appearance of the impact site and Figure 6b identifies three areas with significant features which are shown at higher magnifications in Figures 6c, d, and e. Again, as was the case with the 0.7 mm diameter drop impact site, the fractures are predominantly transgranular (Figure 6c) with some intergranular fracture included near the inner radius (Figure 6d). Dislocation etch pits at the inner radius are shown in Figure 6e.

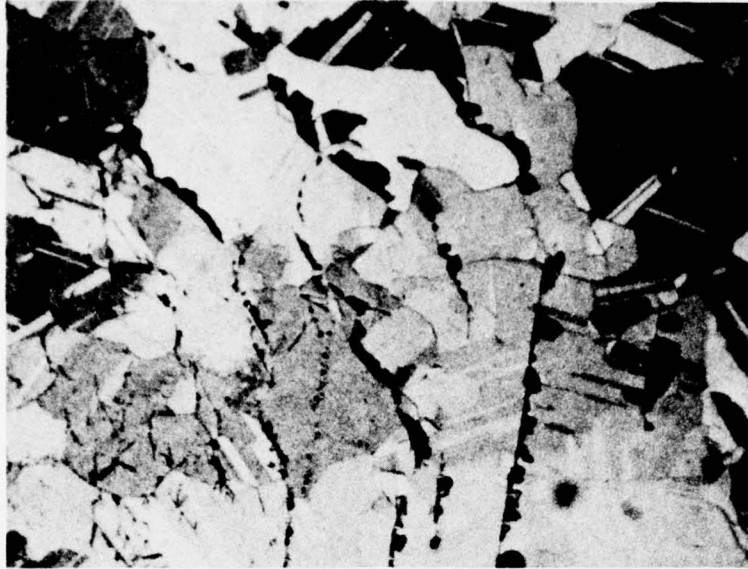
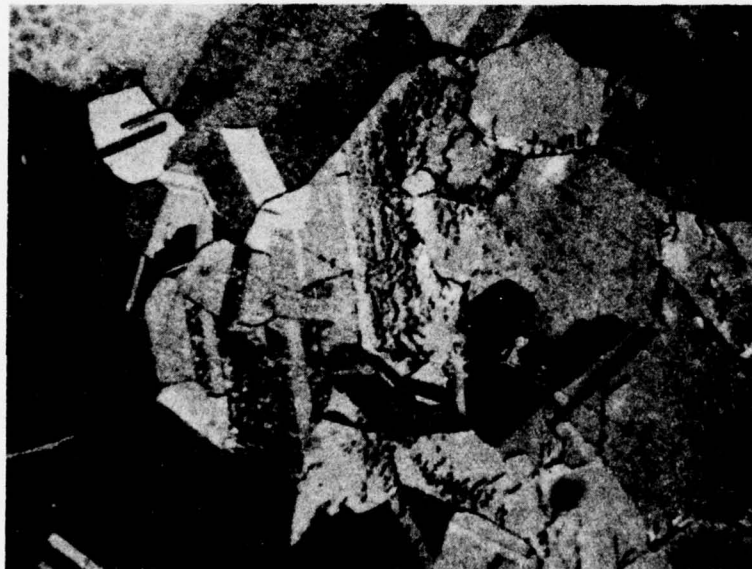
a. Overall Appearance, Transmitted Light. Mag. 30X

b. Appearance of Right Side. Mag 135X

Figure 7. Ring Fracture on Zinc Selenide Formed by Impact with 2.5 mm Diameter Drop at 730 fps. Reflected Light Except Where Noted (Continued)

c. Transgranular Cracks in Area A. Mag. 250X

d. Etch Pits at Inner Radius of Ring Fracture in Area B. Mag. 470X

**Figure 7. Ring Fracture on Zinc Selenide Formed by Impact with 2.5 mm Diameter Drop
at 730 fps. Reflected Light Except Where Noted
(Concluded)**

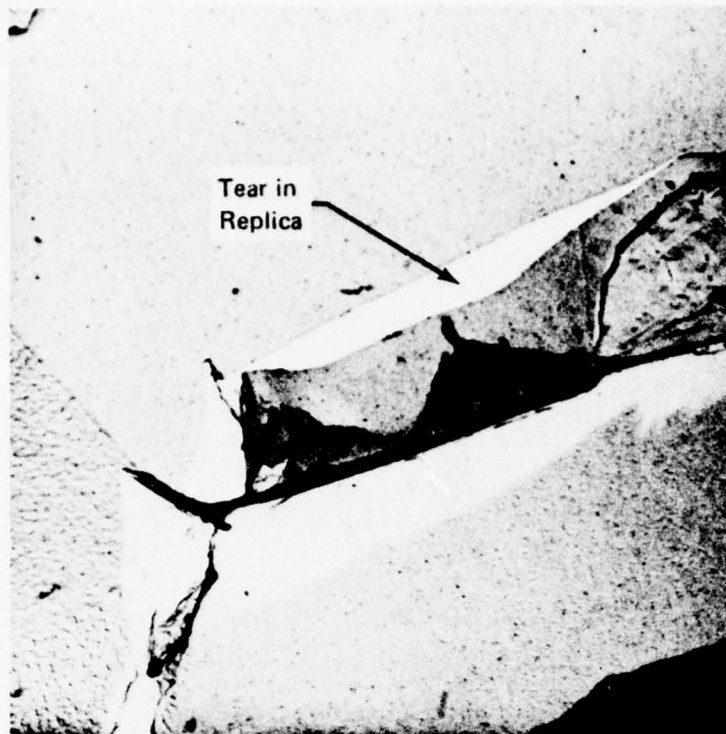
a. Cracking and Chipping at Grain Boundaries

b. Mixed Intergranular and Transgranular Cracks

Figure 8. Electron Micrographs of Ring Fractures at Site of Impact of 0.7 mm Diameter Drop on Zinc Selenide. Mag. 2000X

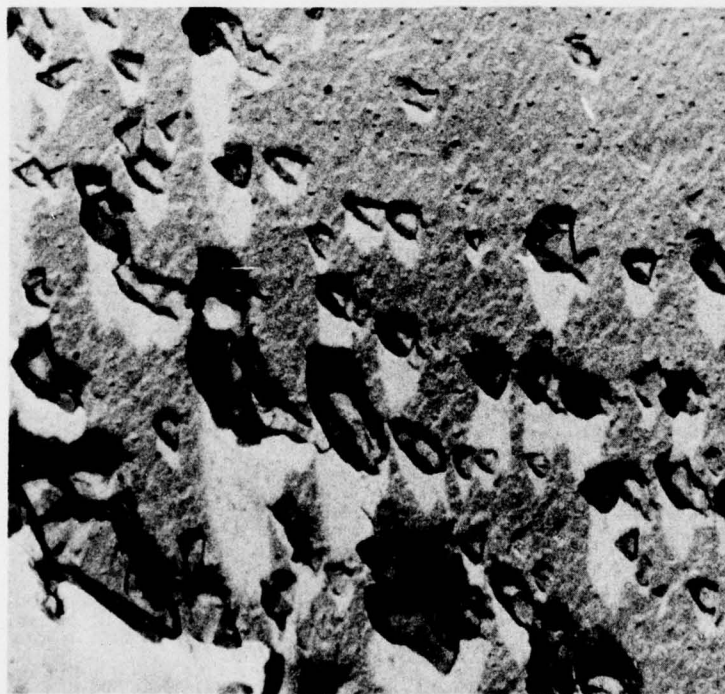
Figure 10. Electron Micrographs of Dislocation Etch Pits at Site of Impact of 2.0 mm Diameter Drop on Zinc Selenide

Electron micrographs of etched zinc selenide specimens showing various features of the ring fractures at higher magnifications are presented in Figures 8, 9 and 10. Both the intergranular and the transgranular natures of the cracks near the inner radius of the ring fracture formed by the impact of a 0.7 mm diameter drop are shown in Figure 8. Figure 9a shows a typical transgranular crack formed by the impact of a 2.5 mm diameter drop. This type of transgranular cracking is also common to the ring fractures formed by 0.7 and 2.0 mm diameter drops. Figure 9b reveals intergranular cracking within the ring fracture formed by the 2.5 mm diameter drop. At the lower magnifications obtained with optical microscopy (Figure 7), intergranular cracks could not be definitely identified. The intergranular crack in Figure 9b is obviously very narrow. Figure 10 shows dislocation etch pits found near the inner radius of the ring fracture formed by the impact of a 2.0 mm drop. The tetrahedral shape of the pits formed on grains oriented in the $\langle 111 \rangle$ direction is evident even though the specimen was over-etched. The etch pits found at ring fractures formed by 0.7 and 2.5 mm drops were similar to those shown in Figure 10.

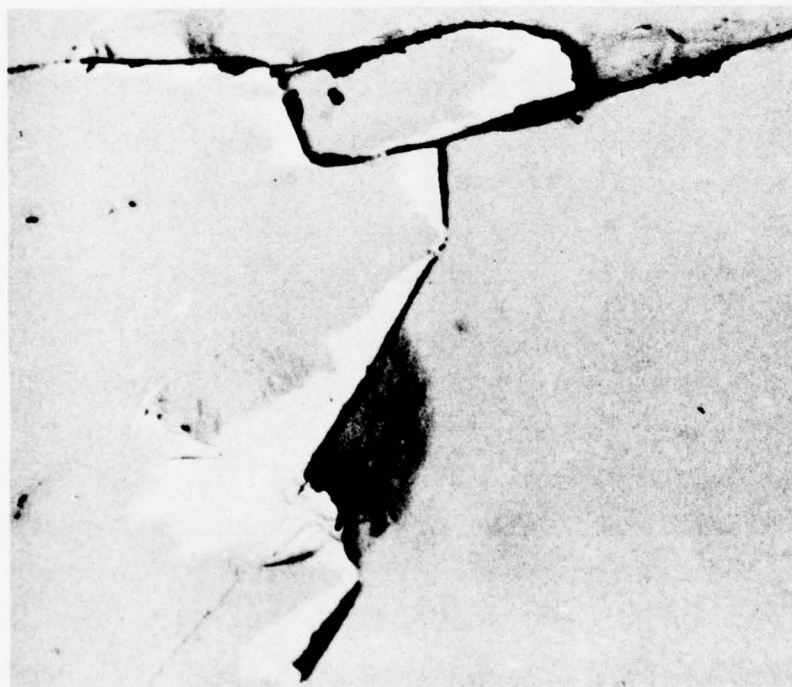
Figure 23. Electron Micrographs of Typical Cracks in the Overlap Regions of Doublet Impact Sites on Gallium Arsenide Impacted by 2.0 mm Diameter Water Drops at 730 fps. Mag. 3400X

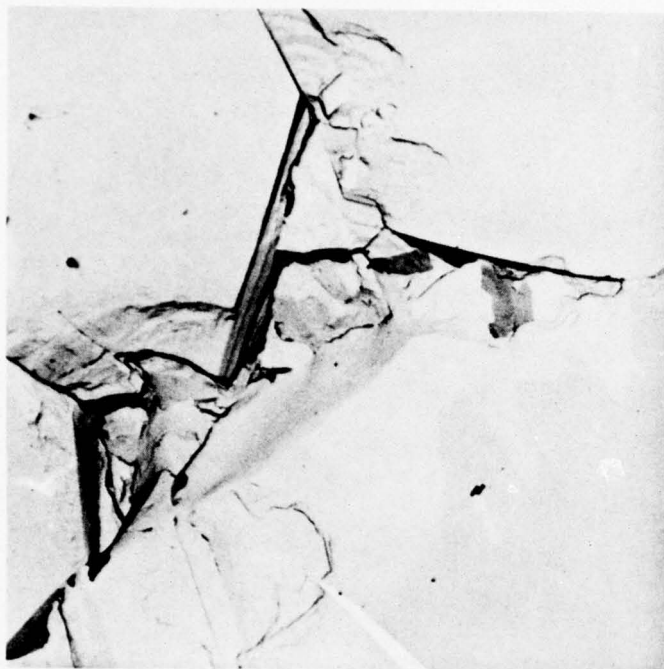
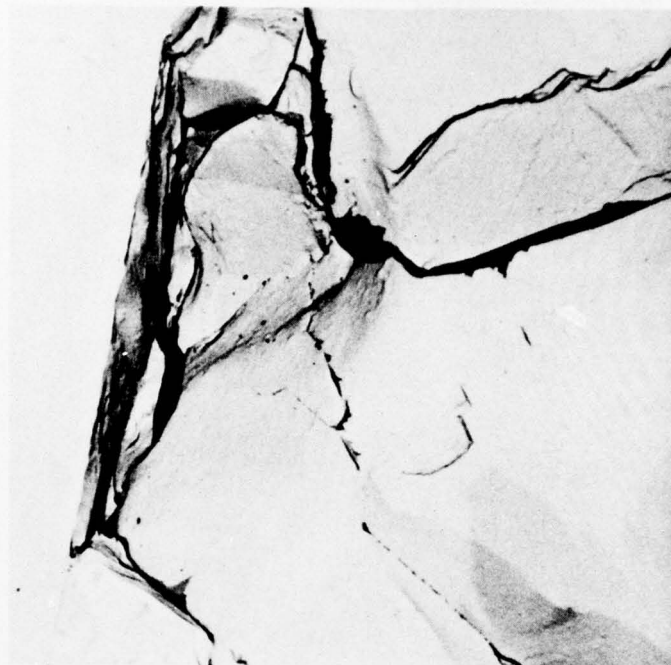
a. Intersecting Ring Fractures

Figure 36. Electron Micrographs of Typical Damage on Zinc Selenide Exposed for 20 seconds to the Standard Rainfield (1 inch/hour, 1.8 mm Drops) at 730 fps.

Electron micrographs representative of various stages of erosion in the rainfield for zinc selenide, gallium arsenide, and zinc sulfide are presented in Figures 36, 37 and 38, respectively. The extensive damage of zinc selenide from multiple impacts after only 20 seconds of exposure is quite apparent in Figure 36. Cleavage steps can be seen at the bottom of the large pit shown in the lower two micrographs of this figure. The

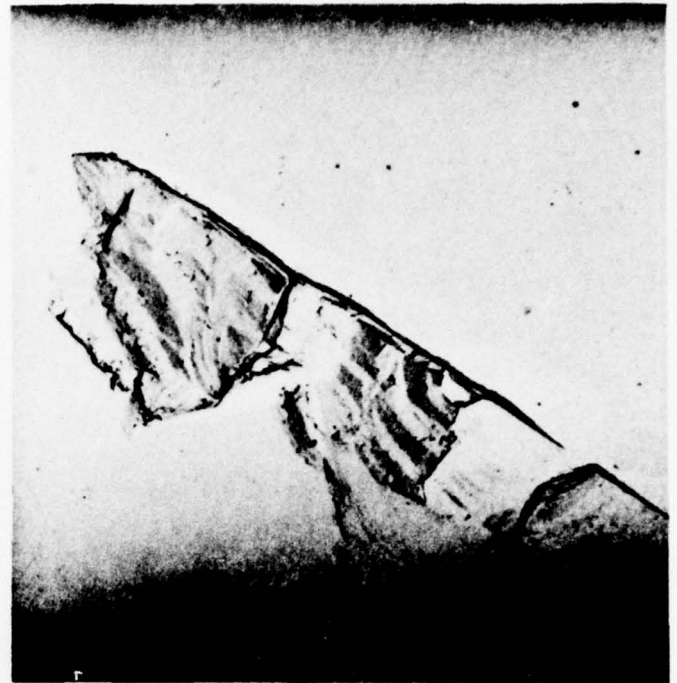
Figure 37. Electron Micrographs of Typical Damage on Gallium Arsenide Exposed to the Standard Rainfield (1 inch/hour, 1.8 mm Drops) at 730 fps. Mag. 2000X

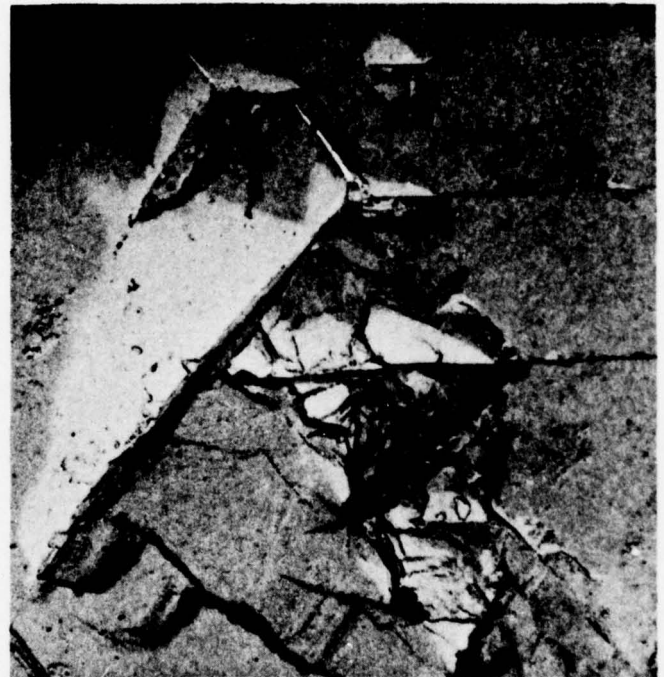
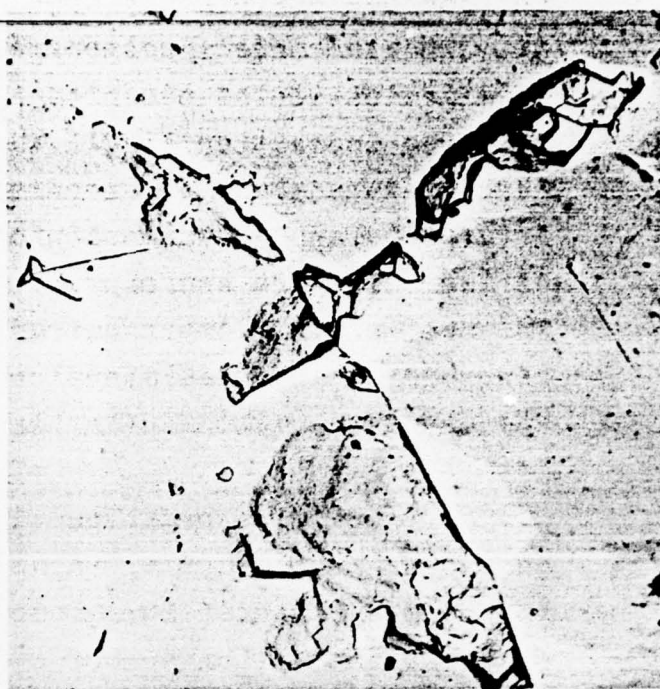
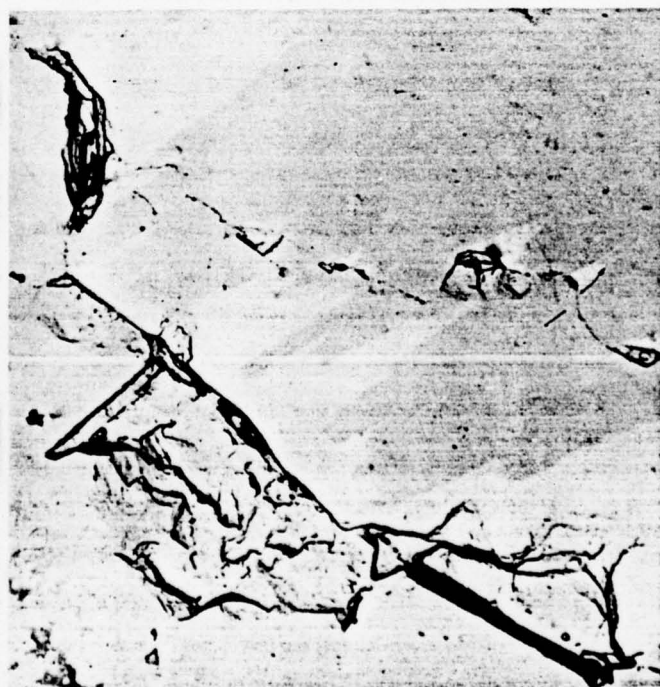
Figure 38. Electron Micrographs of Typical Damage on Zinc Sulfide Exposed to the Standard Rainfield (1 inch/hour, 1.8 mm Drops) at 730 fps. Mag. 2000X

The limited cracking of zinc sulfide after 20 seconds in the rainfield (Figure 38a) is quite similar to that of the single drop impact sites (Figure 4d). After 40 seconds (Figure 38b), enhanced damage at intersecting ring fractures becomes apparent. Cleavage in the relatively small pit nucleated after 80 seconds can be seen in Figure 38c. Figure 38d, after 160 seconds of exposure, shows the deepest crack found during the electron microscopic examination of the replicas obtained from the zinc sulfide specimen exposed to the rainfield. The depth of this crack is approximately 0.01 mm (0.0004") based on the length of the shadow cast on the replica.

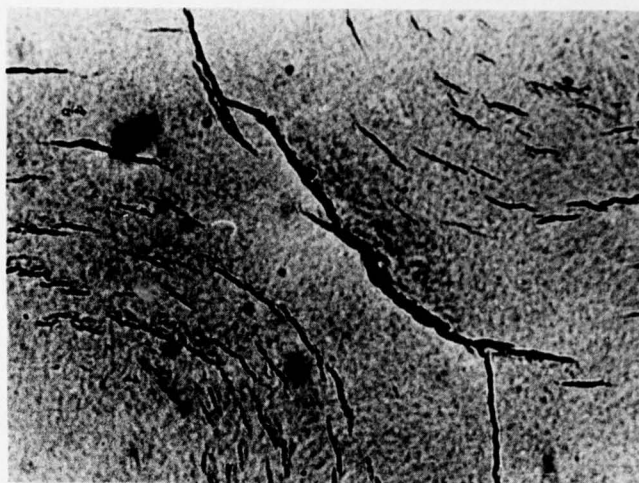
Figure 43. Overlapping Doublet Impact Sites on Front Surface of 0.25 mm Thick Layer of Zinc Sulfide Bonded to Zinc Selenide. Surface Impacted by 2.0 mm Single Water Drops at 730 fps.

The damage at the sites of overlapping ring fractures on the zinc sulfide protective layers was found to be no greater than that exhibited previously by overlapping ring fractures on bulk zinc sulfide. An example of a doublet overlapping impact site on the thinnest (0.25 mm) zinc sulfide layer is shown in Figure 43. The impact of the second drop did not enhance the damage caused by the first drop.

The 0.25 and 0.50 mm zinc sulfide layers were removed from the zinc selenide substrates by boiling the specimens in a decementing agent. The protected front faces of the zinc selenide substrates and the back faces of the zinc sulfide layers were then examined. No evidence of impact damage was found on either of the zinc selenide substrates. Figure 47 illustrates the appearance, from the back face, of typical impact sites on the 0.25 mm zinc sulfide layer. These sites are the same overlapping doublet shown from the front face in Figure 43. It is apparent from Figure 47b that the fractures did not extend through the protective layer.

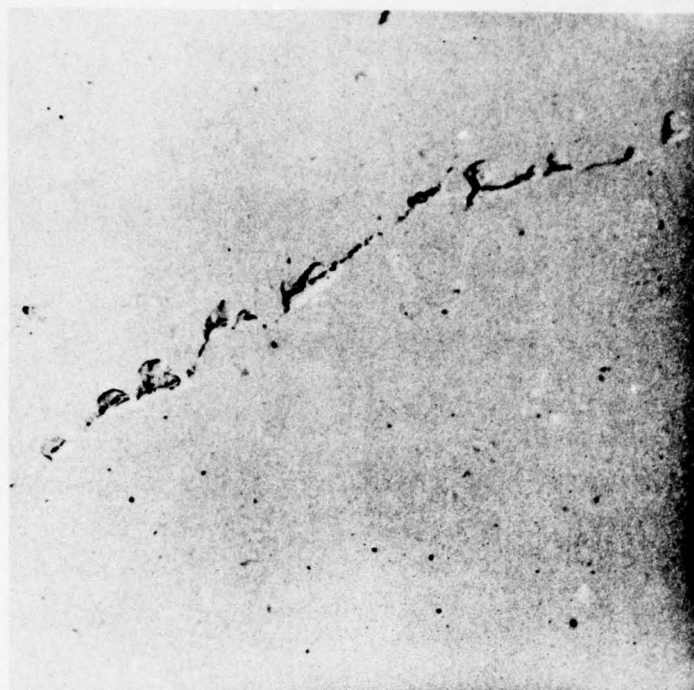
Figure 44. Electron Micrographs of Ring Fractures Formed by 2.0 mm Drop Impact at 730 fps. on 0.25 mm Thick Zinc Sulfide Layer Bonded to Zinc Selenide. Mag. 2000X

An electron microscopic analysis of impact sites on the three thicknesses of zinc sulfide layers verified that the ring fractures were similar to those on the homogeneous zinc sulfide specimens impacted earlier. Electron micrographs of ring fractures are presented in Figures 44, 45 and 46 for zinc sulfide layer thicknesses of 0.25, 0.50 and 1.0 mm, respectively. Contrary to the conclusion based on the optical microscopic examination, chipping of the ring fractures occurred on all three thicknesses.

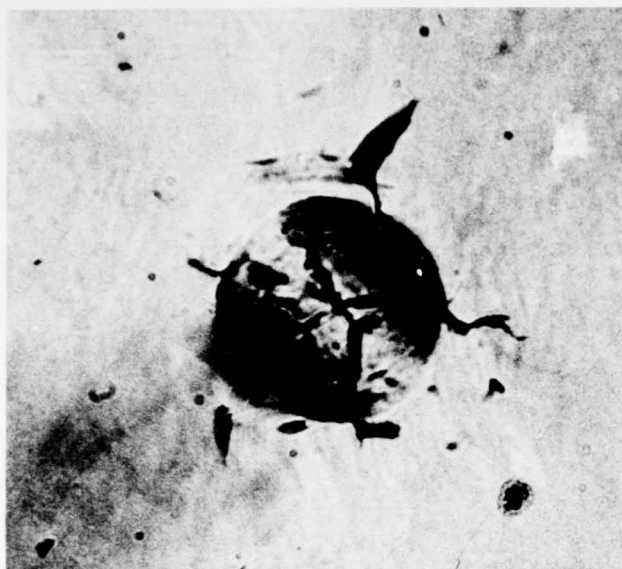
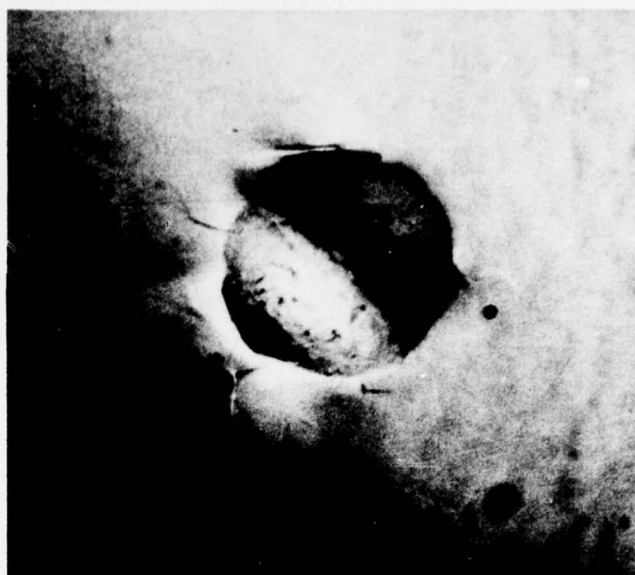
Figure 49. Typical Fractures Produced by Quasistatic Loads Applied by a $407\text{ }\mu\text{m}$ Diameter Al_2O_3 Sphere. Mag. $290\times$

The experimental arrangement was the same as described in Reference 1. The specimens were loaded by a 407 micron diameter sapphire sphere while the contact area was viewed from the opposite side through a microscope focused through the specimen onto the loaded surface. The load was slowly applied until a fracture was observed. At this point, the loading was stopped, the fracture load was recorded, and the diameter of the fracture was measured. The test was then repeated at a new area until the desired number of readings was obtained.

Examples of the fractures on zinc selenide and zinc sulfide are shown in Figure 49. Histograms of fracture loads

a. Zinc Selenide
